Restoration To The Main Temple Building of The *Cheng Hoon Teng* Temple

By Ir. Tan Hoon Keong

After a dilapidation study on the 400-year old *Cheng Hoon Teng* Temple, restoration work on the main temple building commenced in April 1999 and was completed in December 2000. All engineering works were carried out by local contractors while the intricate mouldings and carvings were done by artisans from China.

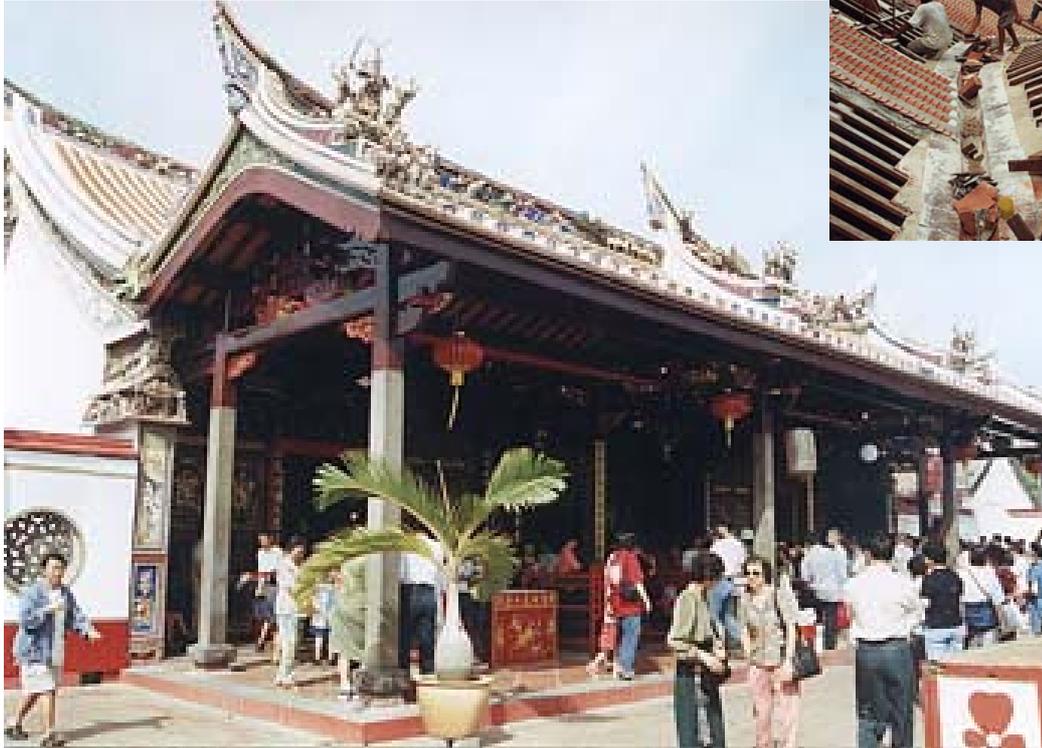
Turtle hump roof

The roof of the main prayer hall is connected to that of the outer prayer pavilion by a “turtle hump”. This is an ingenious way of channelling the rainfall to both ends of the gutter and out through the mouth of a mythical creature called “Hou Yee”. The turtle hump thus flushes the rainwater and thereby eliminates water stagnation.

The rain gutter was constructed entirely of lime mortar and broken pieces of tiles and bricks. The gutter was supported by a 8” x 9” wooden beam. This mode of construction had over the years, caused the gutter to deteriorate and hence exacerbated the decay of the beam. The importance of the gutter prompted the restoration committee to replace it with a copper gutter. This effectively solves the leakage problem and prolongs the life span of the gutter beam.

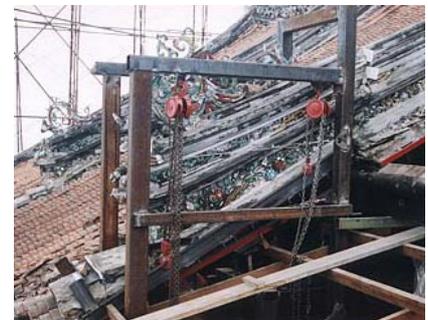
Hoisting Frame

All the sloping secondary ridges cracked at the column support positions as a result of failure of the supporting battens due to termite attack. Miraculously the main ridge remained intact throughout, as the oval-shaped beams that supported the main ridge were all unharmed by this voracious pest. Applying the principle of conservation, the restoration committee decided that these sloping ridges should be restored and not remoulded (see Table 1).

In order to remove the termite-infested beams, an *in-situ* hoisting frame was fabricated. It consisted of heavy-duty mild steel hollow sections, which was then strategically tied to the existing temporary supports for added stability. Four chain blocks were then installed, one at each corner of the frame.

The lower cracked section was carefully lifted by about 1" to facilitate the removal of the decayed beam and

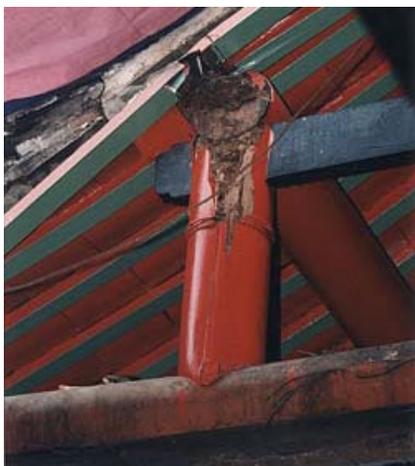
Replacement of Decayed Interactive Structural Members

the other structural members. The replacement of these members proved to be more difficult than anticipated due to the complexity of the joints. Indeed it required a lot of dexterity, co-ordination and patience to install these interactive structural members within a confined space .

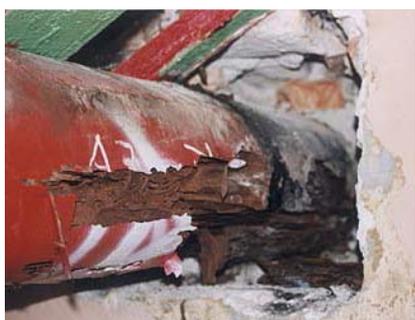
Decayed Beam End

It was found that most of the beams were attacked by termites from the end that were embedded in the walls. The restoration committee recommended that all the ends of the new beams be protected by a coat of anti-termite chemical and the embedded ends be protected further with copper sleeves. Copper was chosen because it is a natural wood preservative. This was confirmed when it was discovered that some old beams had copper sleeves and some with galvanised iron sleeves. The ends of these beams with copper sleeves remain intact while those with galvanised iron sleeves had decayed substantially.
