Restoration To The Main Temple Building of The *Cheng Hoon Teng* Temple

By Ir. Tan Hoon Keong

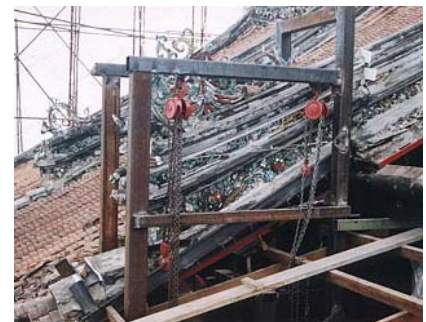
Hoisting Frame

In order to remove the termite-infested beams, an *in-situ* hoisting frame was fabricated. It consisted of heavy-duty mild steel hollow sections, which was then strategically tied to the existing temporary supports for added stability. Four chain blocks were then installed, one at each corner of the frame.

The lower cracked section was carefully lifted by about 1" to facilitate the removal of the decayed beam and

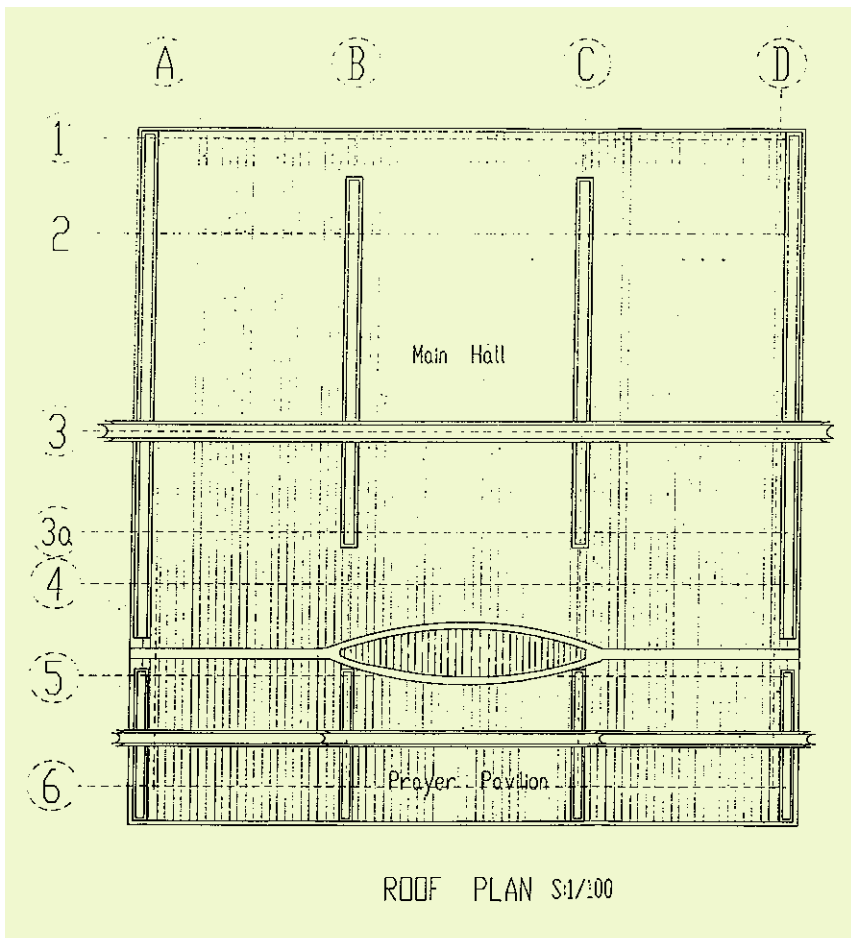
Roof plan

All the sloping secondary ridges cracked at the column support positions as a result of failure of the supporting battens due to termite attack. Miraculously the main ridge remained intact throughout, as the oval-shaped beams that supported the main ridge were all unharmed by this voracious pest. Applying the principle of conservation, the restoration committee decided that these sloping ridges should be restored and not remoulded (see Table 1).

The temple's roof structure comprises of a main ridge and four secondary sloping ridges (see roof plan). The main ridge sits on huge oval-shaped wooded beams while the sloping secondary ridges sit on a 2" x 1"

The replacement of the 2" x 4" batten beneath the sloping ridge proved to be as challenging. The restoration committee decided to strengthen this batten to avoid similar failure of the sloping ridge in the future.

A piece of heavy-duty mild steel c-channel was first sand-blasted and then coated with anti-rust paint. This c-channel was then placed snugly above the batten. Some 1" diameter stainless steel studs were also welded to the c-channel to provide additional grip

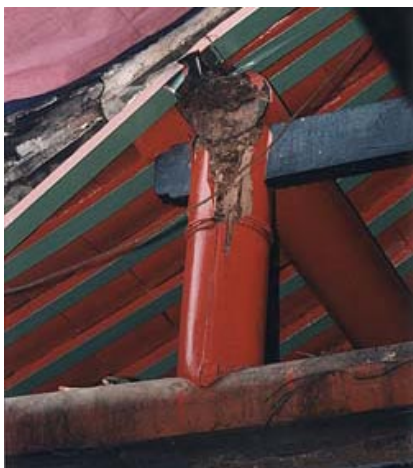
Replacement of Decayed Interactive Structural Members

the other structural members. The replacement of these members proved to be more difficult than anticipated due to the complexity of the joints. Indeed it required a lot of dexterity, coordination and patience to install these interactive structural members within a confined space .

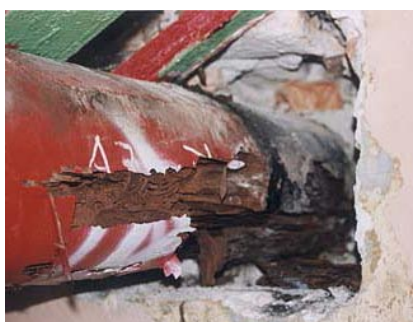
Decayed Beam End

It was found that most of the beams were attacked by termites from the end that were embedded in the walls. The restoration committee recommended that all the ends of the new beams be protected by a coat of anti-termite chemical and the embedded ends be protected further with copper sleeves. Copper was chosen because it is a natural wood preservative. This was confirmed when it was discovered that some old beams had copper sleeves and some with galvanised iron sleeves. The ends of these beams with copper sleeves remain intact while those with galvanised iron sleeves had decayed substantially.
