Restoration To The Main Temple Building of The *Cheng Hoon Teng* Temple

By Ir. Tan Hoon Keong

After a dilapidation study on the 400-year old *Cheng Hoon Teng* Temple, restoration work on the main temple building commenced in April 1999 and was completed in December 2000. All engineering works were carried out by local contractors while the intricate mouldings and carvings were done by artisans from China.

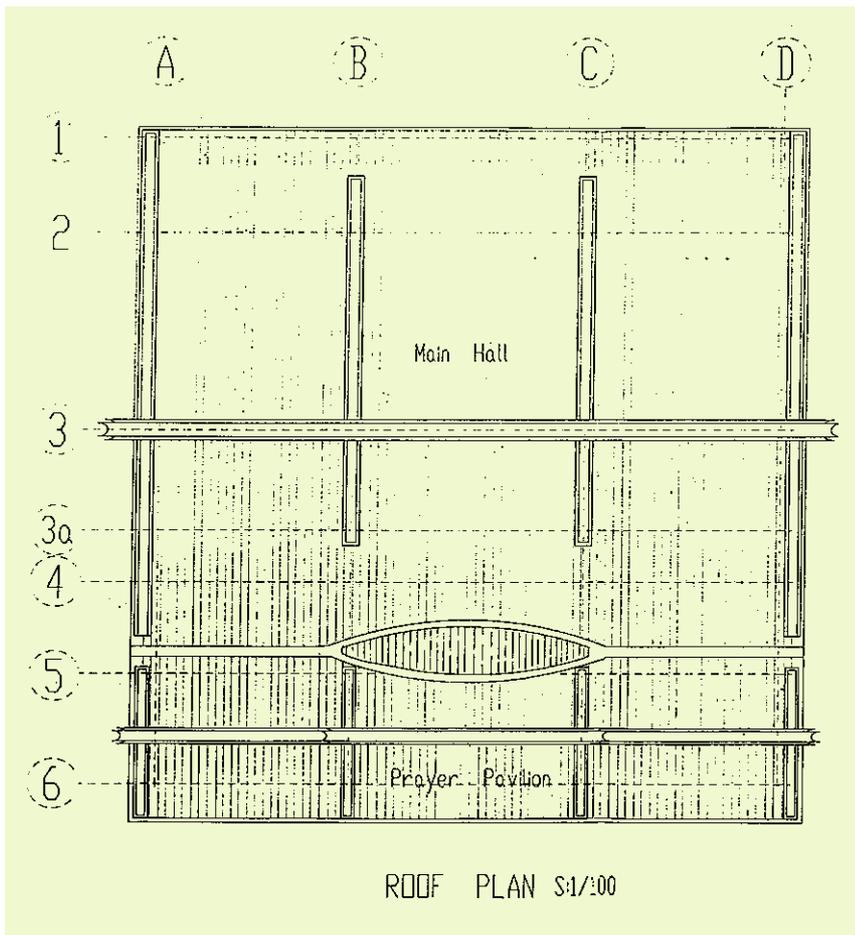
Roof plan

The temple's roof structure comprises of a main ridge and four secondary sloping ridges (see roof plan). The main ridge sits on huge oval-shaped wooded beams while the sloping secondary ridges sit on a 2" x 1"

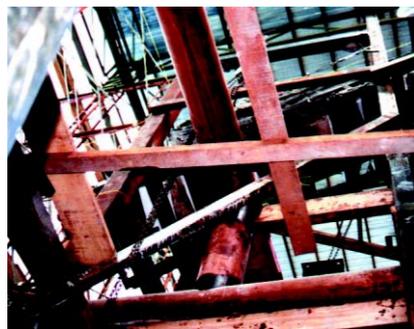
It was found that most of the beams were attacked by termites from the end that were embedded in the walls. The restoration committee recommended that all the ends of the new beams be protected by a coat of anti-termite chemical and the embedded ends be protected further with copper sleeves. Copper was chosen because it is a natural wood preservative. This was confirmed when it was discovered that some old beams had copper sleeves and some with galvanised iron sleeves. The ends of these beams with copper sleeves remain intact while those with galvanised iron sleeves had decayed substantially.

Decayed Beam End
