Restoration To The Main Temple Building of The *Cheng Hoon Teng* Temple

By Ir. Tan Hoon Keong

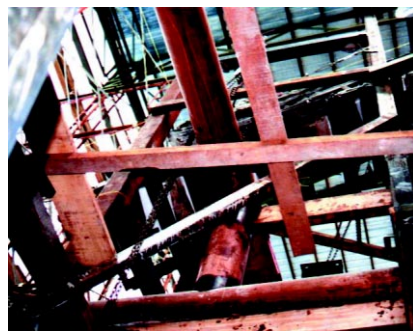
It was found that most of the beams were attacked by termites from the end that were embedded in the walls. The restoration committee recommended that all the ends of the new beams be protected by a coat of anti-termite chemical and the embedded ends be protected further with copper sleeves. Copper was chosen because it is a natural wood preservative. This was confirmed when it was discovered that some old beams had copper sleeves and some with galvanised iron sleeves. The ends of these beams with copper sleeves remain intact while those with galvanised iron sleeves had decayed substantially.

Decayed Beam End
